# Foundation Drilling

# Anderson Drilling Scores on the 18th Hole Near Palos Verdes, California

By Dan Cadenhead, President  
Anderson Drilling Company  
Lakeside, California

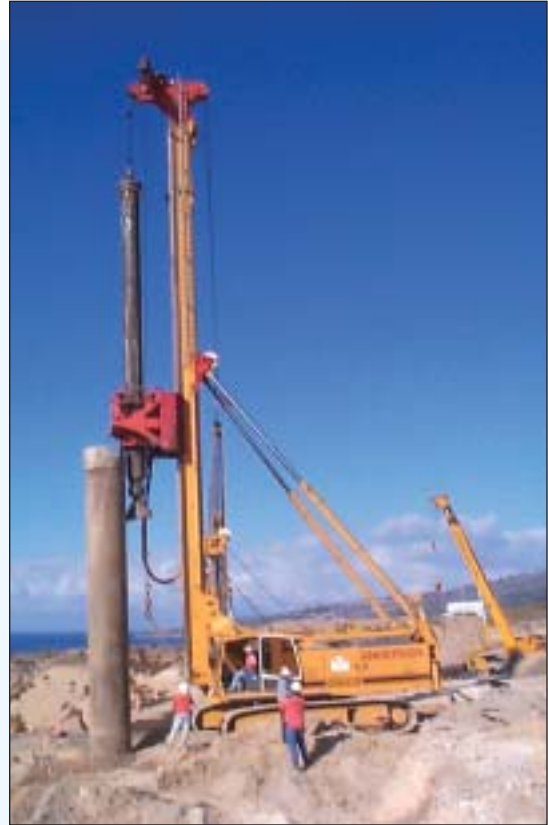
*Wirth ECO 35 installs shear pin.*

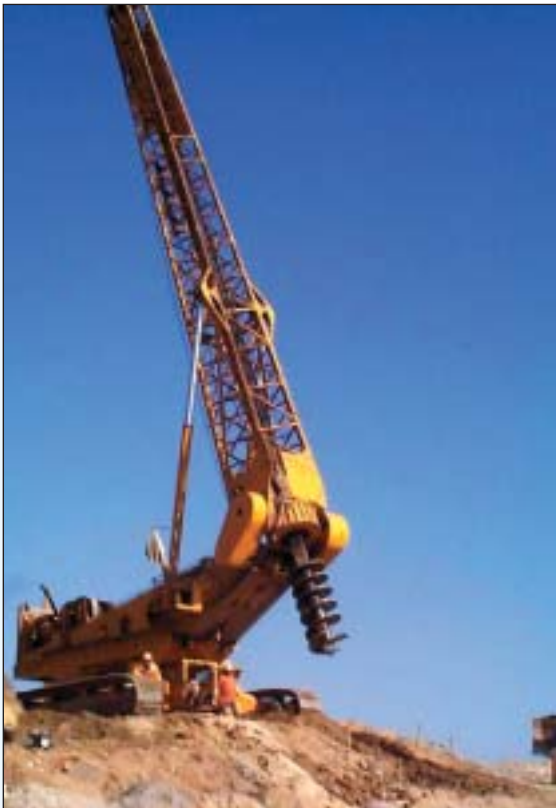
*"Big Stan Moving" to a new shear pin location.*

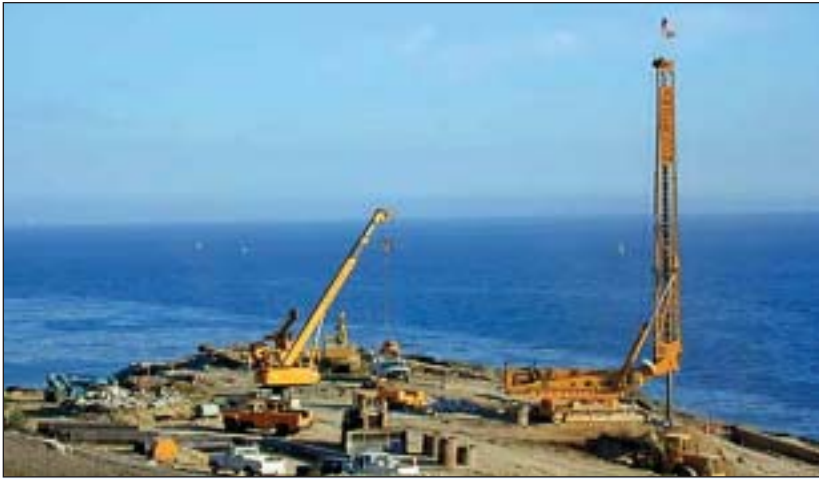
*"Big Stan" and Mantis crane overlooking Pacific Ocean.*

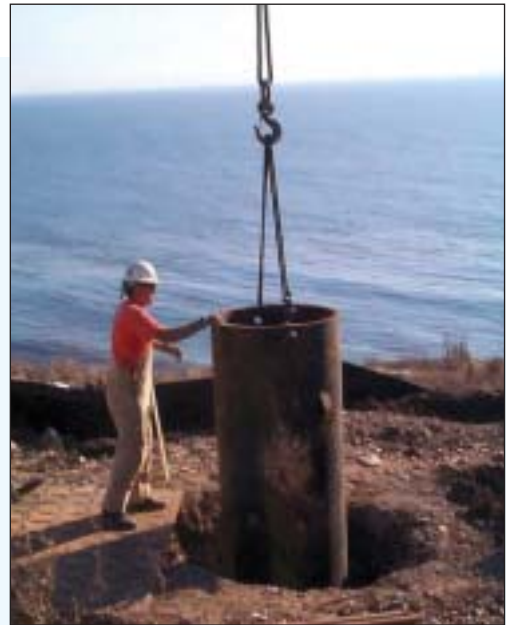
*Crew setting shear pin.*

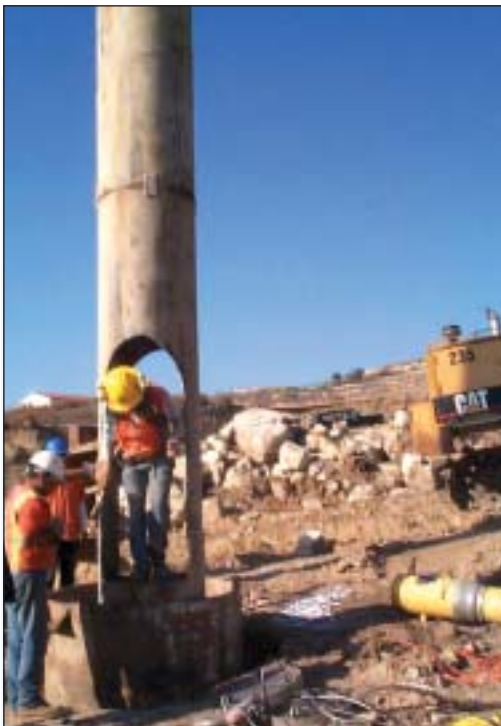
*Geologist prepares for down-hole inspection.*

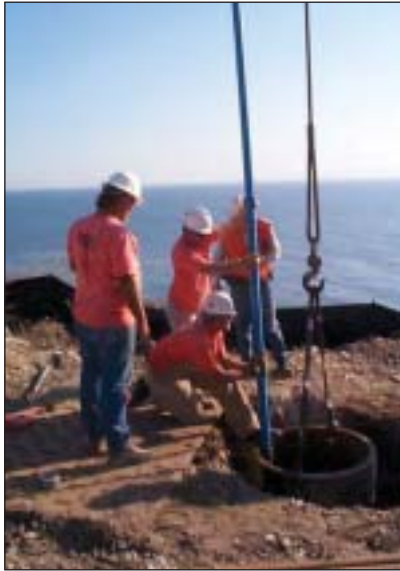
Crew installs inclinometer.
