# Foundation Drilling

# Anderson Drilling Scores on the 18th Hole Near Palos Verdes, California

By Dan Cadenhead, President  
Anderson Drilling Company  
Lakeside, California

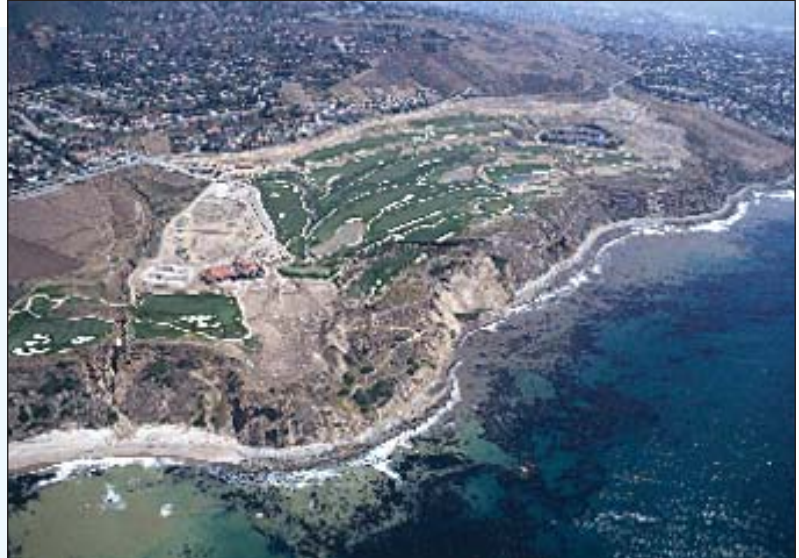
*Aerial view of the Ocean Trails Golf Course.*

ultimately determined that the ancient slide mass, moved on a 4-6" thick layer of bentonite clay. The investigators generally agreed that leakage from a 1955 era sewer pipe that crossed the entire site substantially contributed to the slide movement. The wetted clay layer became the proverbial “slippery slope” for the 18th hole.

The landslide mass moved southward leaving behind a horseshoe shaped feature, open-end toward the ocean. A

large down-dropped “graben” or ditch filled the area between the headscarp and the main slide block. Many open fissures and secondary scarps were created within the main block as the slide moved and broke apart. Some of the deepest fissures extended nearly 90 feet in depth.

The approved landslide mitigation design incorporated the use of shear pins to permanently stop the slide movement and allow for reconstruction of the affected 18th hole. The shear pins consisted of 115 shafts at 42-

inch diameter drilled to approximately 106 feet in depth. As each shaft was excavated to the designed tip a 36-inch diameter casing, 1-1/2 inch thick by 20 feet in length was installed to the bottom of the shaft. A mixture of 4,000 psi concrete was then placed to completely encase the steel casing. Finally, the balance of the shaft was backfilled with a lean sand/cement mixture to near the surface. The intent of the repair design was to get approximately 10 feet of the steel anchor pins into and
