**North Torrey Pines Bridge
in San Diego**

Foundation Drilling

by Dennis M. Poland
 Director of Business Development
 Anderson Drilling

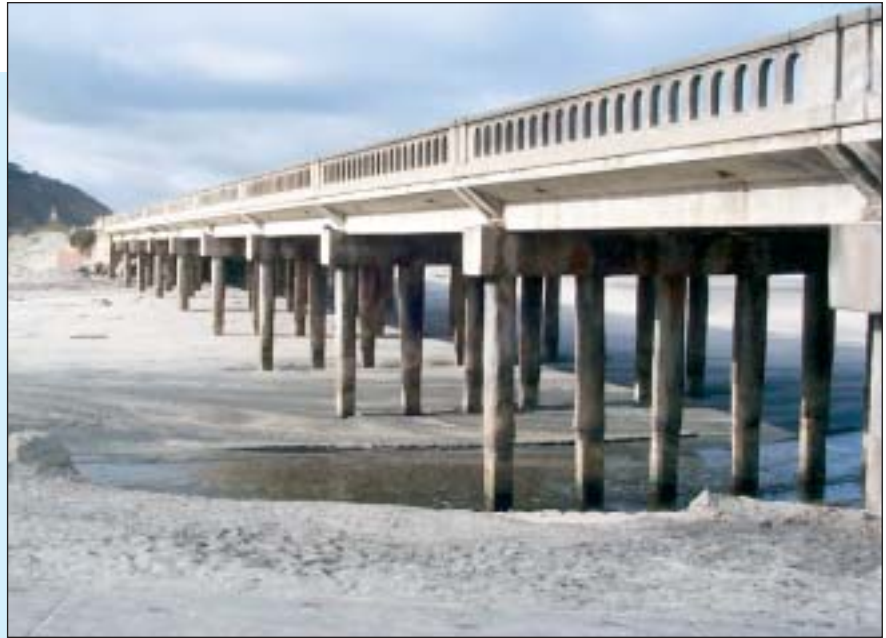
The original 1932 structure was functionally obsolete, structurally deficient and an impediment to lagoon health.

aged structure experienced significant deterioration over the last 10 –15 years. The concrete deck and railing surfaces showed extensive corrosion and the piles were exposed at several locations along the bridge. Occasionally, chunks of concrete fell away from the bridge, to the point that state park officials’ posted hazard warnings to the beach-goers. The configuration of the structure adversely impacted the traveling public since the bridge was significantly narrower than the approach roadway. Additionally, the 72 piles supporting the bridge obstructed the natural flow of water into and out of the adjacent lagoon. Finally, the City of San Diego determined that the bridge was functionally obsolete and structurally deficient. This determination qualified the bridge for Federal Aid Project relief funding for the construction of the new structure.

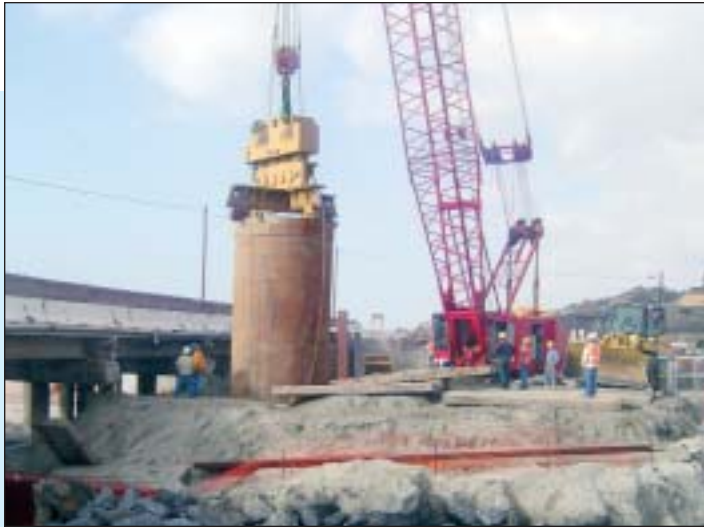
Installing the 111" diameter steel casing with a King Kong quad-clamp vibratory hammer, Pier 3.

The construction sequence for the bridge piles began with vibrating the 111” diameter x 50 ft long x 1” thick steel casing to elev. -40. The casings were installed using an American Pile-Driving Equipment, Inc.* (APE) Model 400 King Kong vibratory hammer held by an Essex* Manitowoc 4100 Series crane. The “quad-clamp” system was used on the 111” diameter pier

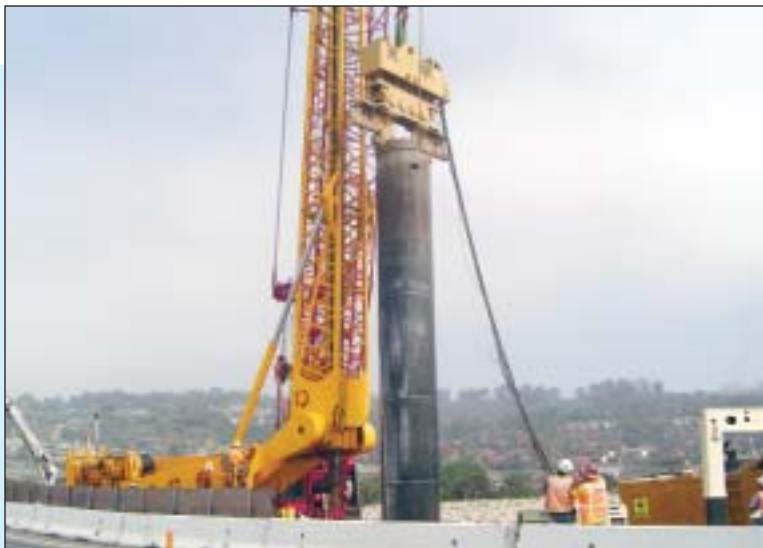
Installing the 60" diameter steel casing with an "APE" King Kong dual-clamp vibratory hammer, Abutment 1.

top. A similar construction method was accepted at the abutment piles, however, since there were no columns (no need for the construction joint) the pipe was considered

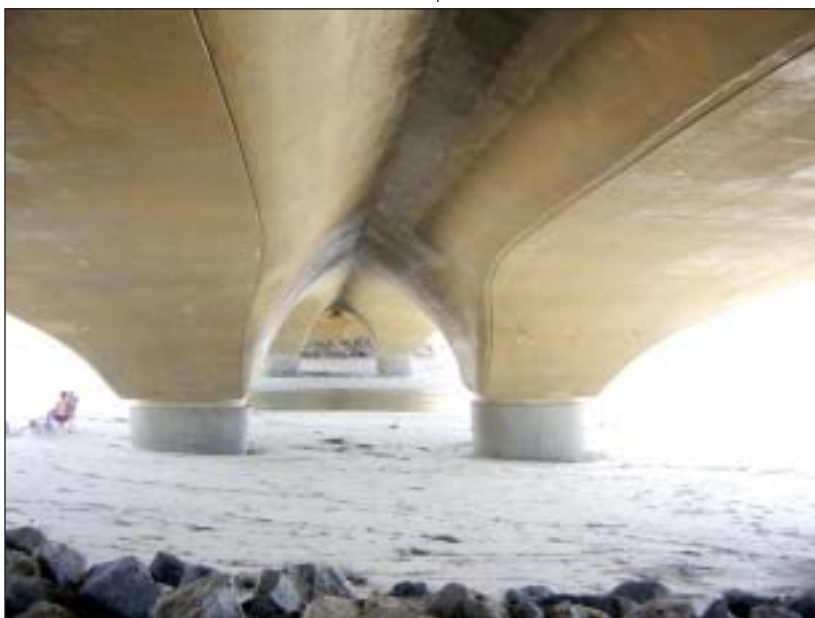
Tidal flow and beach access are unimpeded beneath the new structure.
